# Construction Report for the Quinsam River Fish Passage Improvement Project Campbell River, BC

# Construction Report for the Quinsam River Fish Passage Improvement Project

January 11, 2016

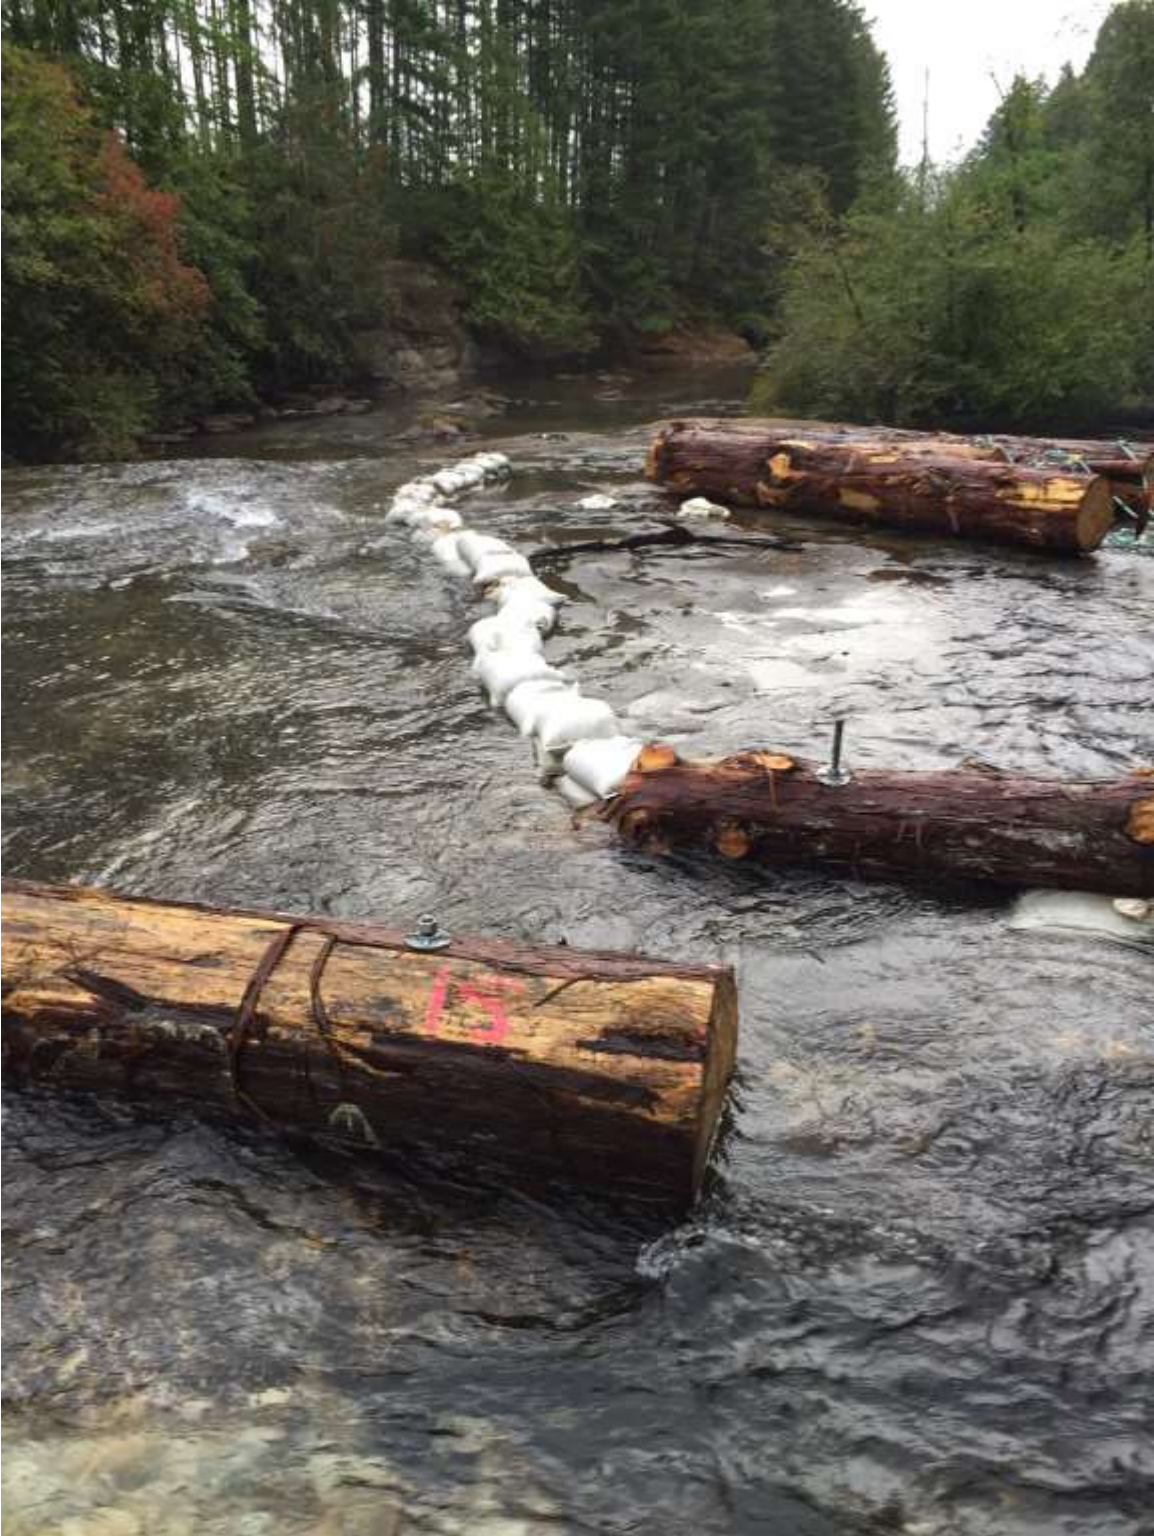
A combination of sand bags, plastic sheeting and gas powered pumps allowed the temporary drying of localized areas within the Quinsam River. Sand bags were found to be most effective if used upstream at approximately a 45° angle to the direction of flow (Photo 3). Flow was also redirected by using sand bags to completely dam areas where flow confined resulting in increased flows through alternate routes (Photo 4). When a localized worksite was not able to be dried completely a dewatering pump was found to be effective if used periodically at the worksite to draw down local water levels (Photo

**Photo 3.** Sand bags placed at a 45° to the direction of flow effectively redirecting the flow of the Quinsam River.

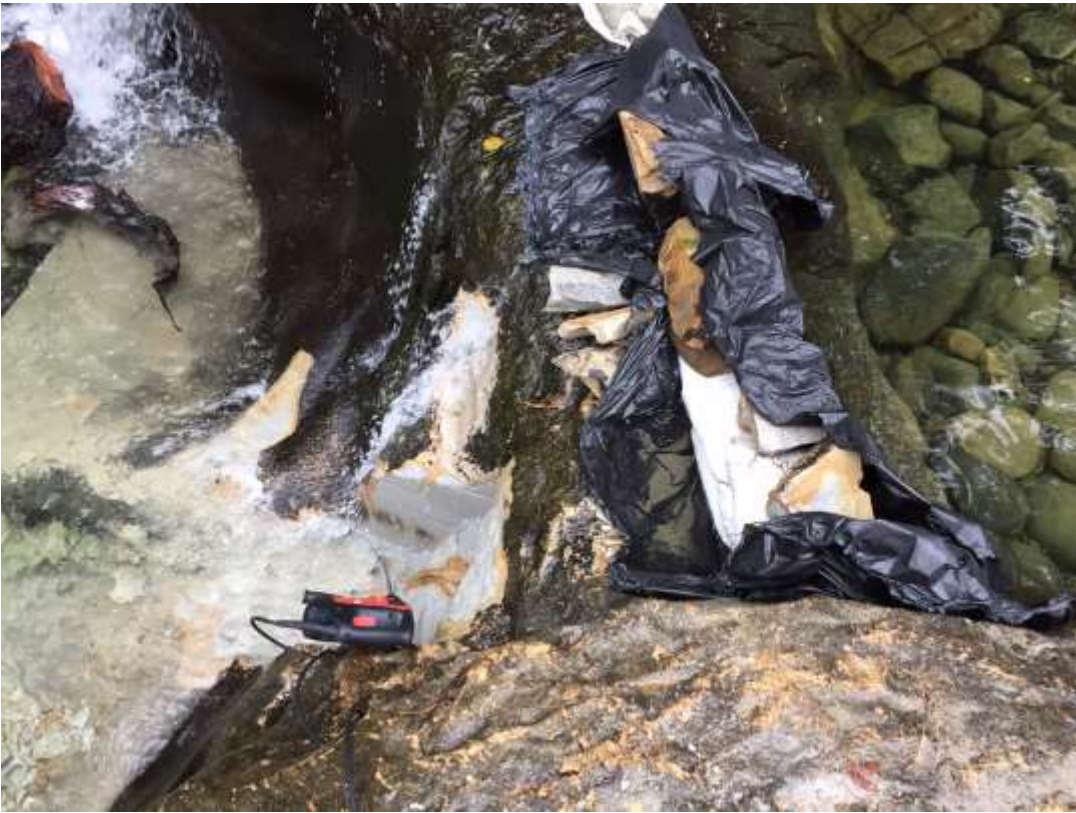
- Plastic sheeting was found to be effective at improving the effectiveness of sandbag features (Photo 4).

**Photo 4.** Plastic sheeting increased effectiveness of sandbag dams.

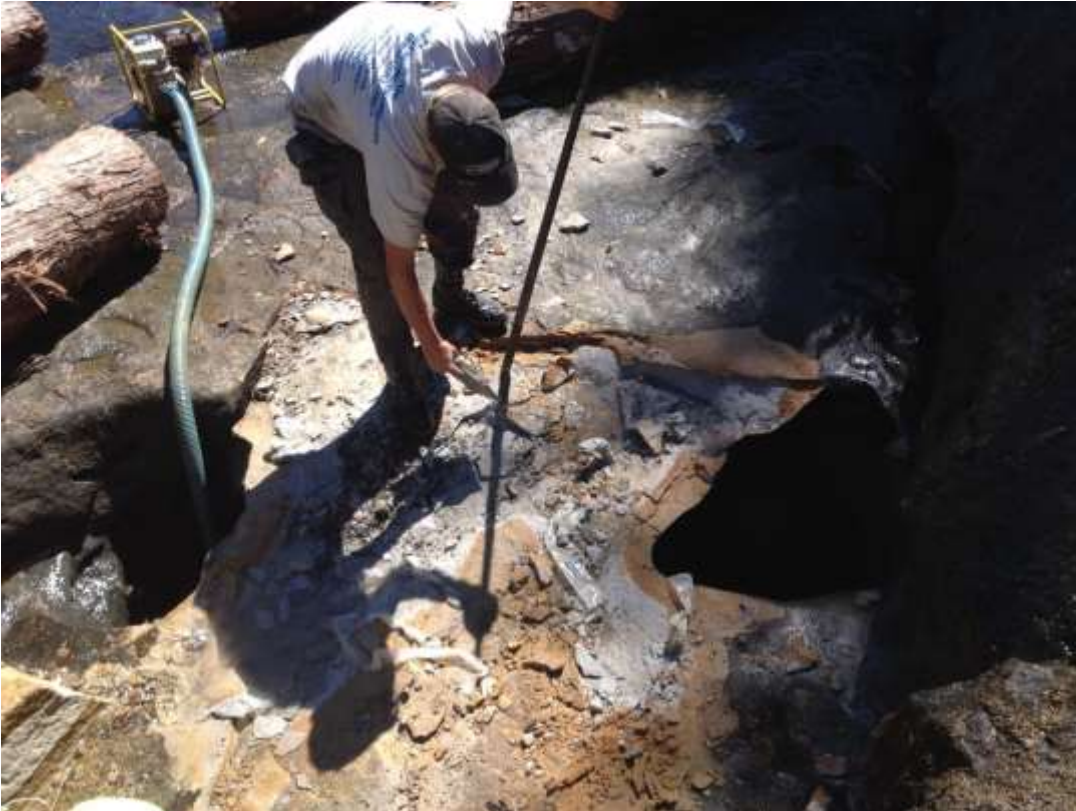
**Photo 5.** Dewatering pump being used effectively to draw down the water level at a localized work area.

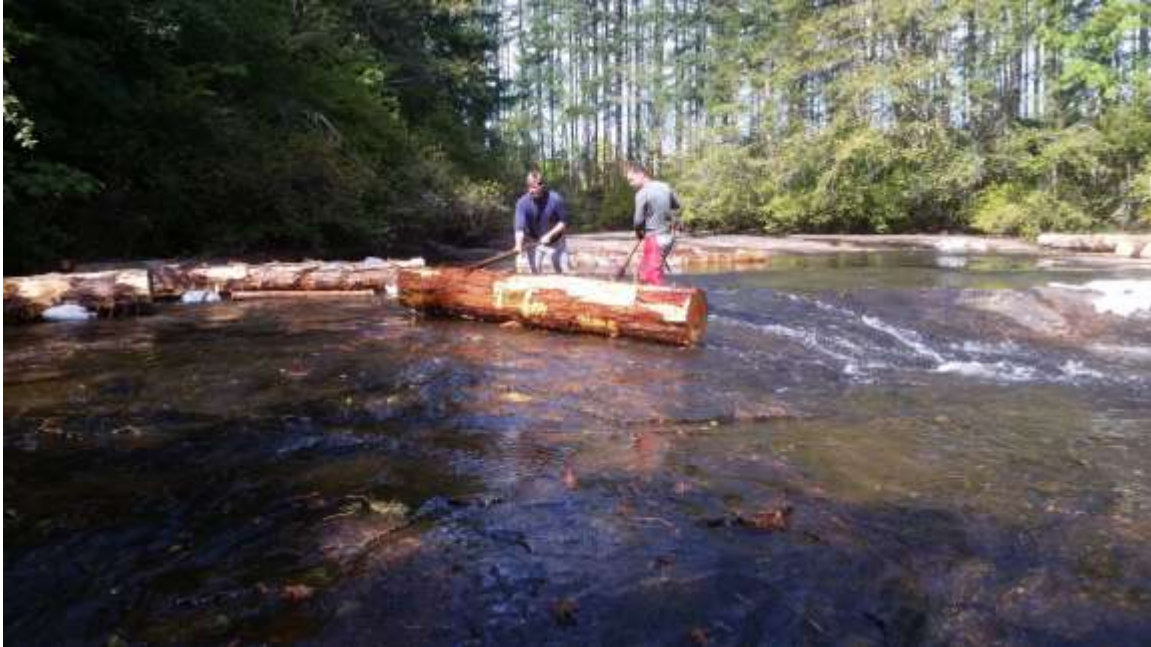
**Photo 6.** Logs being moved into position using Pee Vees.

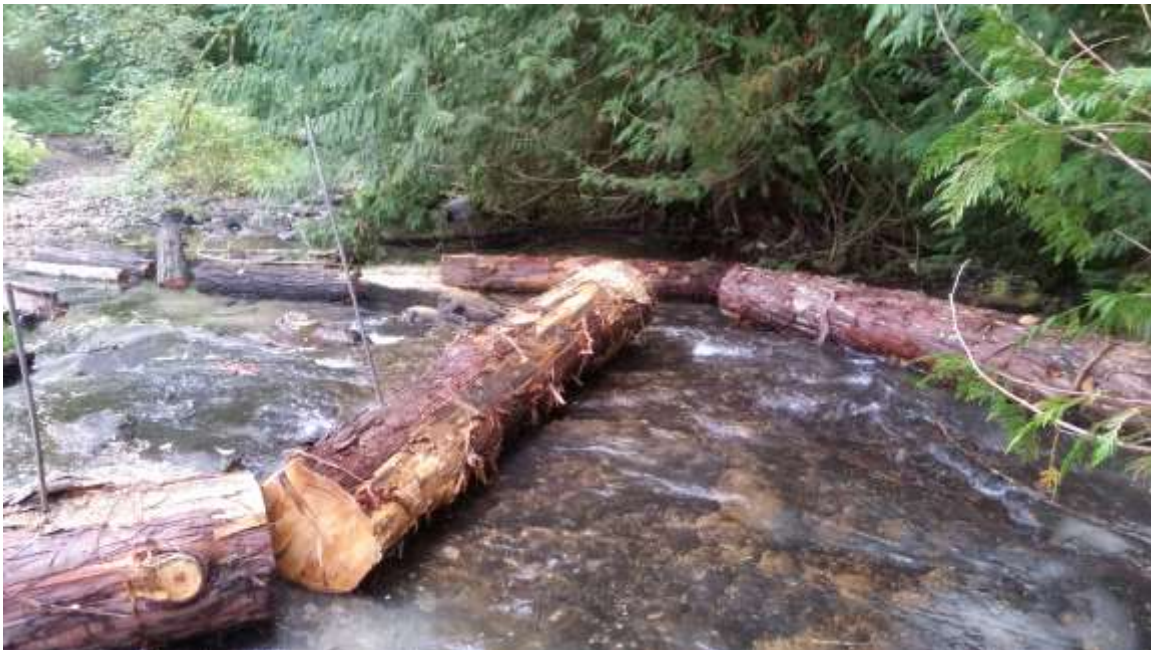
**Photo 7.** Logs being held in position with rebar while they are prepared for anchoring.

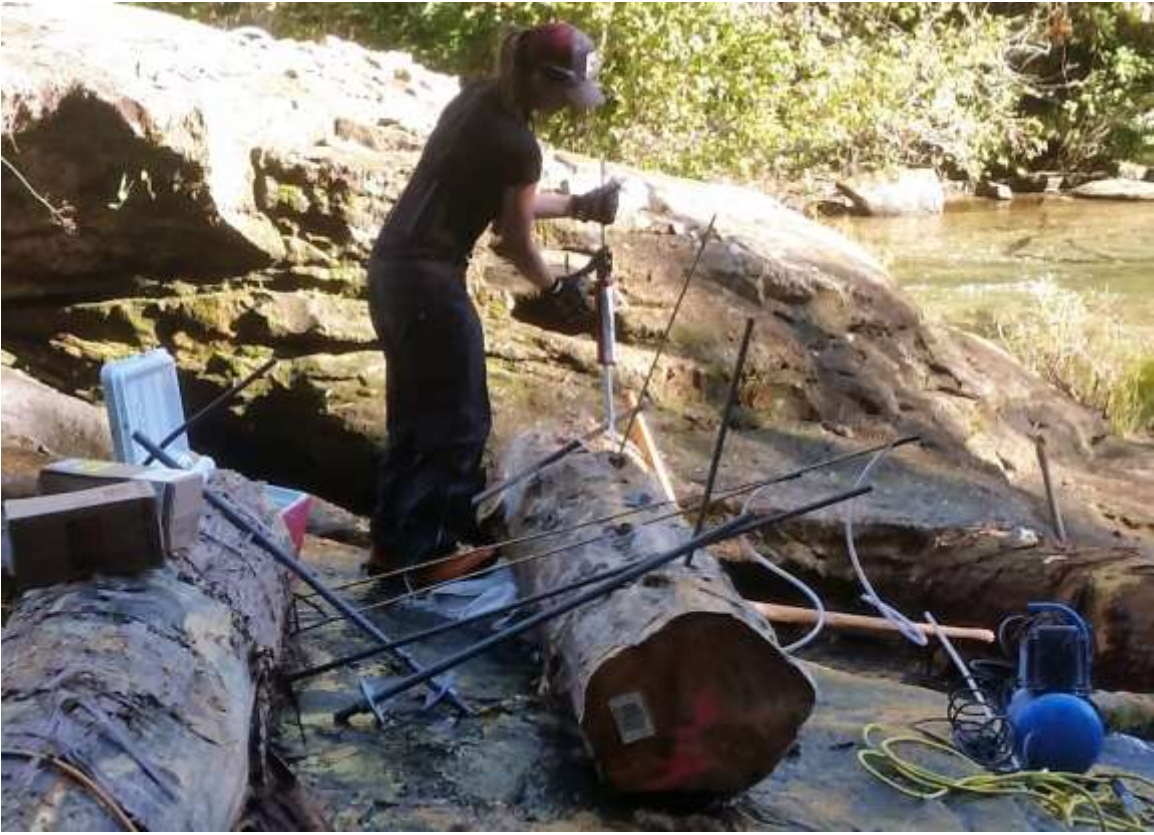
**Photo 8.** Epoxy being applied through flexible plastic tubing to an anchor hole in the bedrock beneath a log.

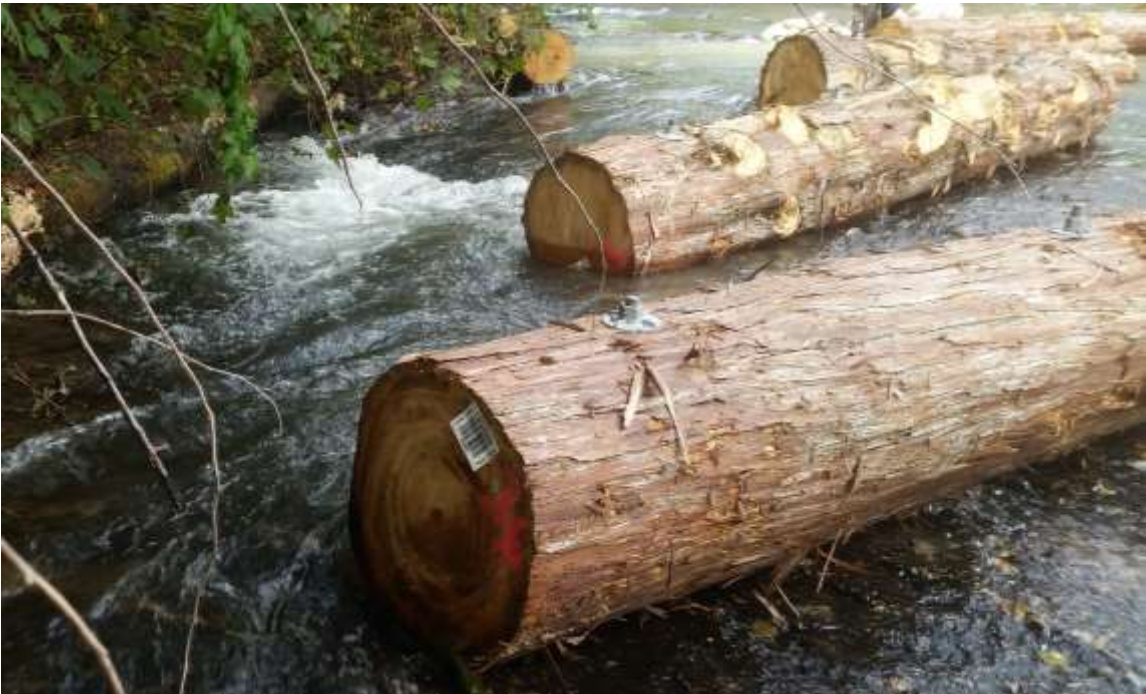
**Photo 9.** Fully anchored log with epoxied galvanized threaded rod, washer and nut attached.

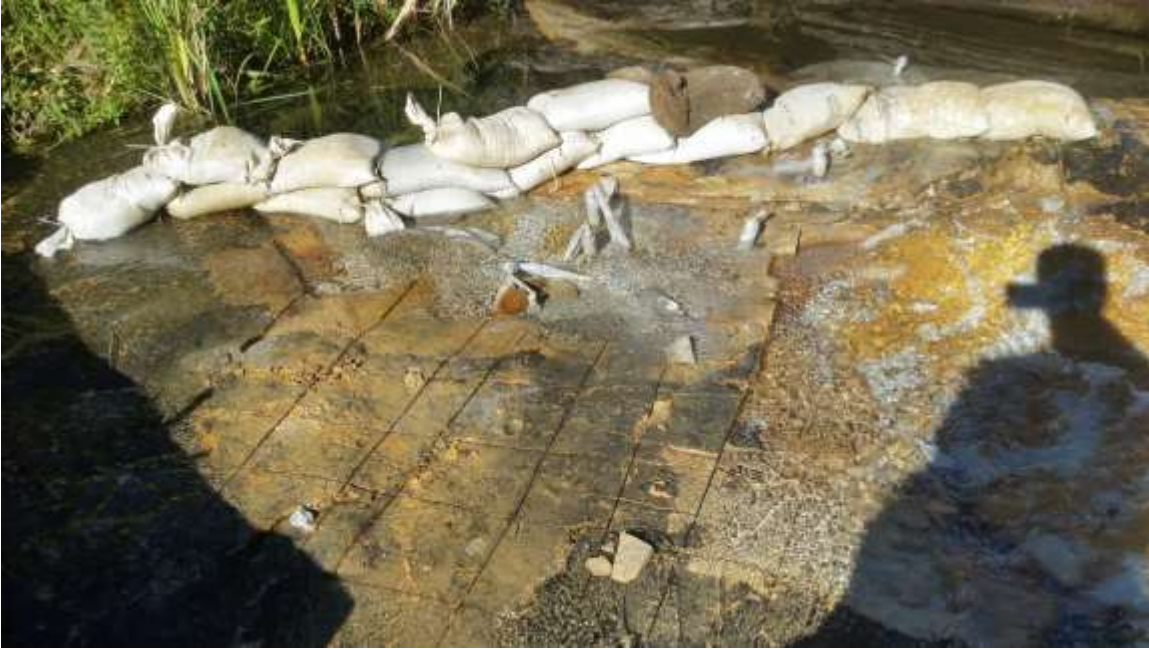
**Photo 10.** Relief cuts in the bedrock improved the effectiveness of the Dexpan. Note the plastic sleeves with the dexpan agent being utilized in standing water. This particular fracture was very successful.

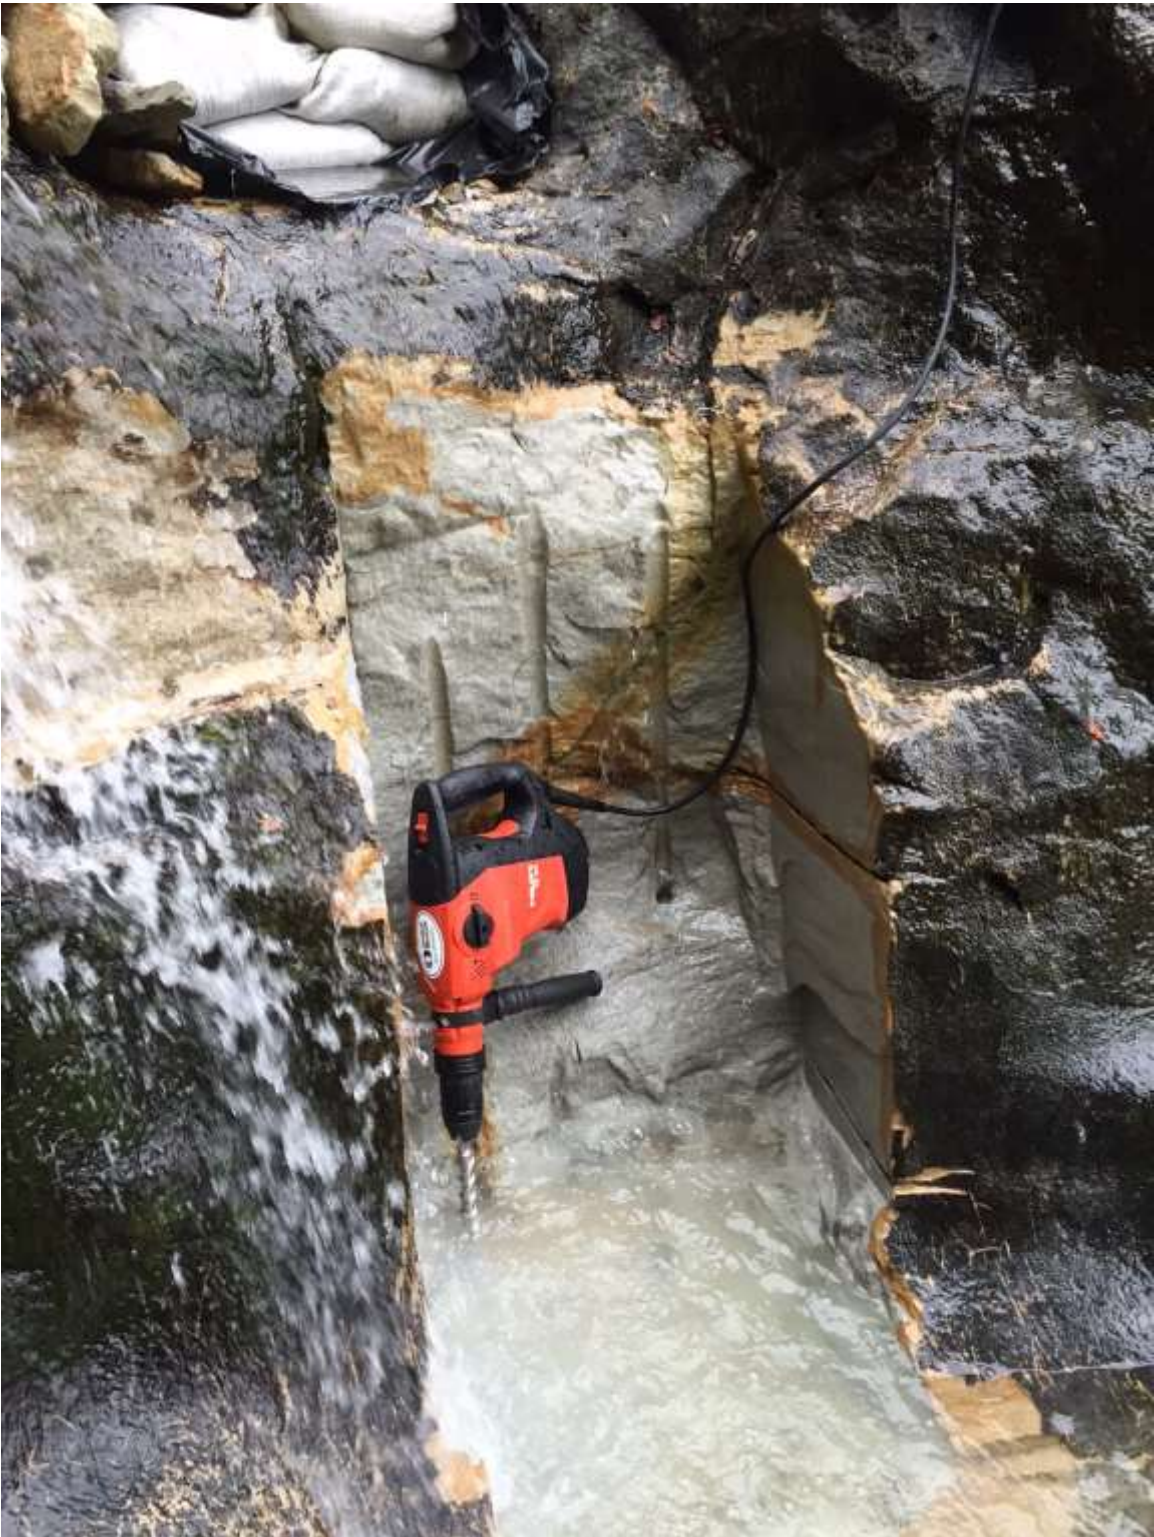
**Photo 11.** Drilling holes for more pressure fracturing beneath an area that was previously successfully fractured by Dexpan. Relief cuts on either side of the excavation were made with a rock chain saw which proved very effective.

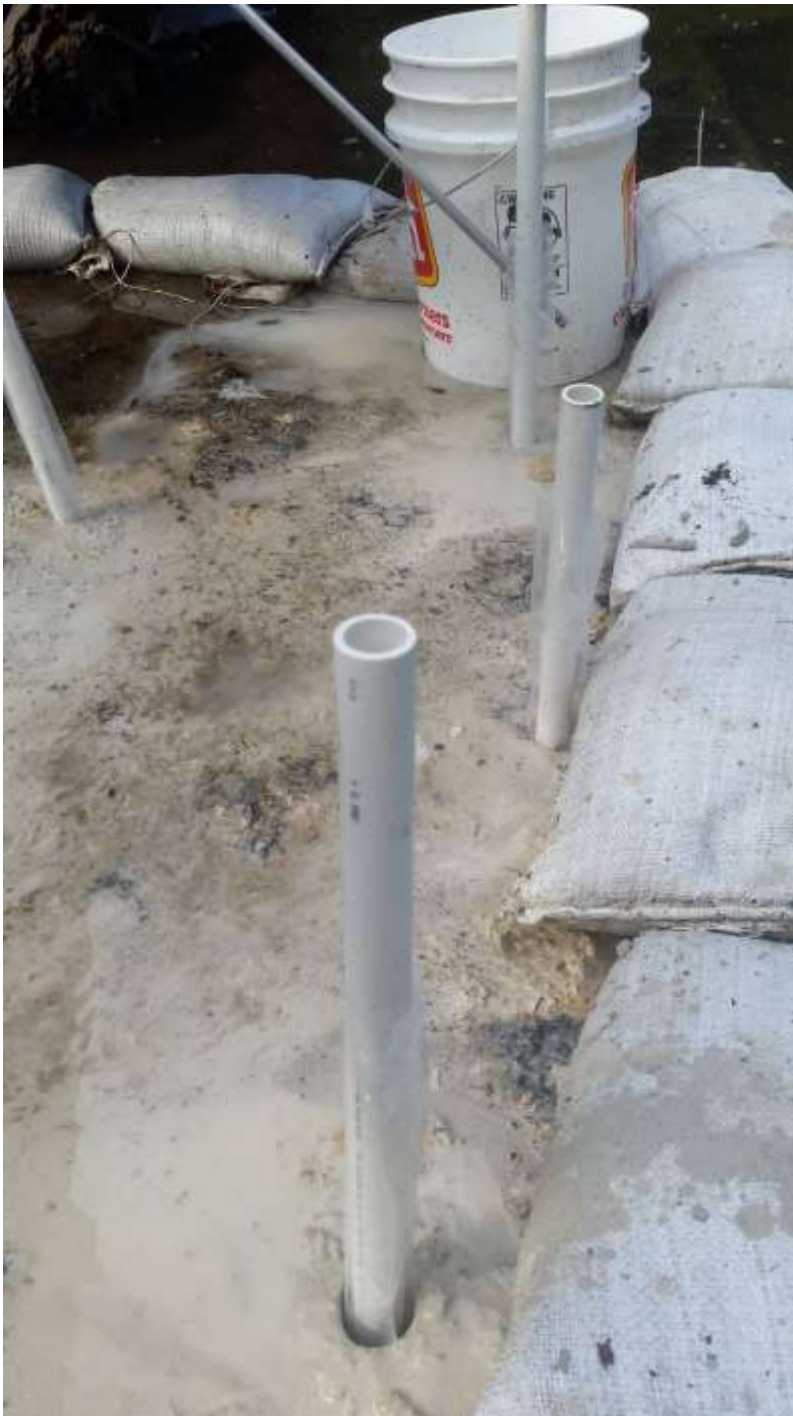
**Photo 12.** Holes drilled and prepared for the pouring of Dexpan. PVC tubing allowed for efficient pouring of Dexpan slurry into the plastic hole liners.

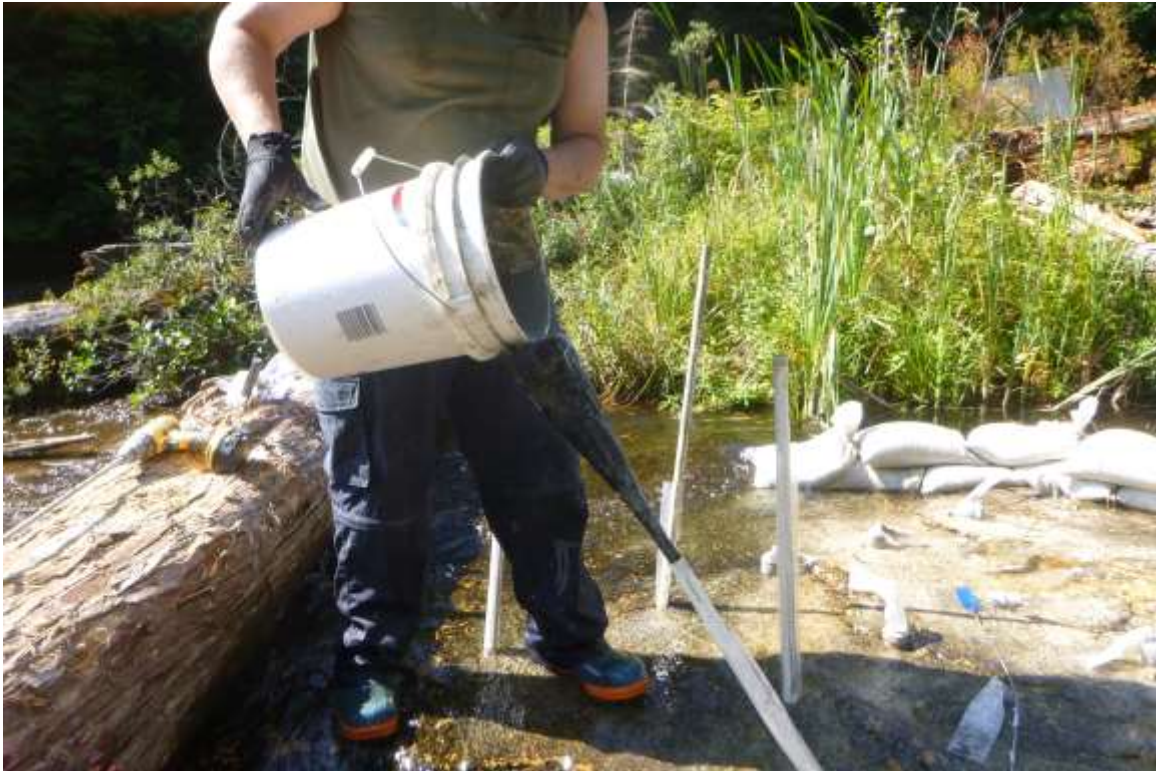
**Photo 13.** Dexpan was mixed in a 5 gallon bucket and poured into the PVC tubing with a funnel.

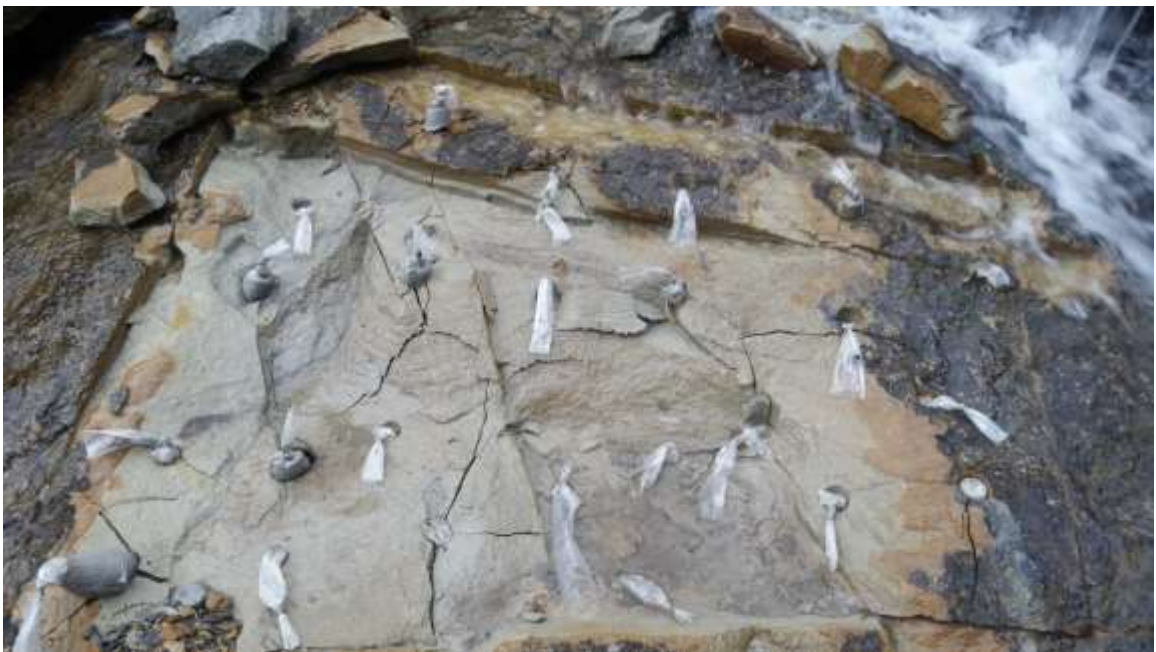
**Photo 14.** After successful pressure fracturing of the bedrock debris could be removed using a demolition hammer, pry bars, or by hand.

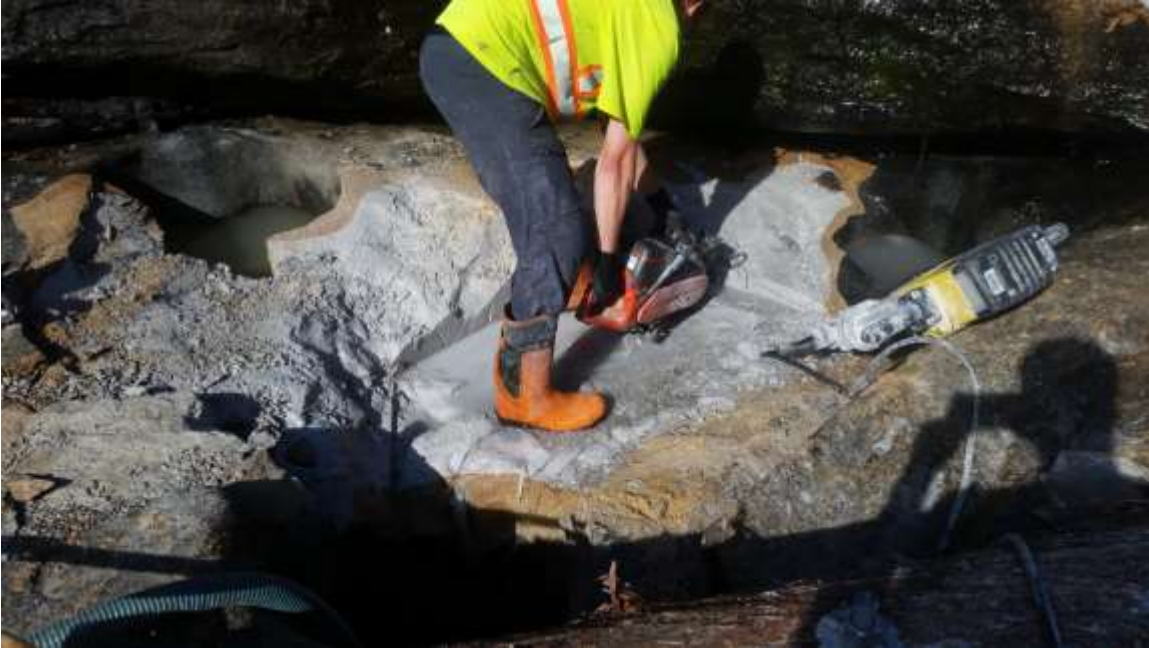
**Photo 15.** Relief cuts made with a line saw improved the efficiency of the demolition hammer.

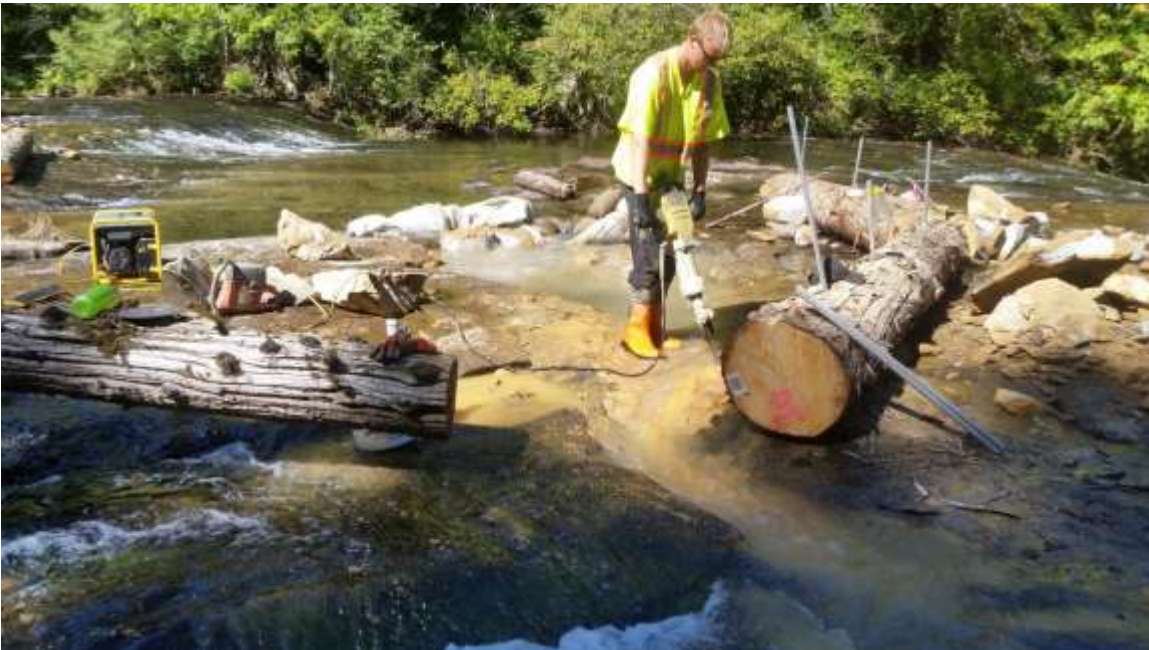
**Photo 16.** Mechanical fracturing of rock was possible with some water flow through the site.

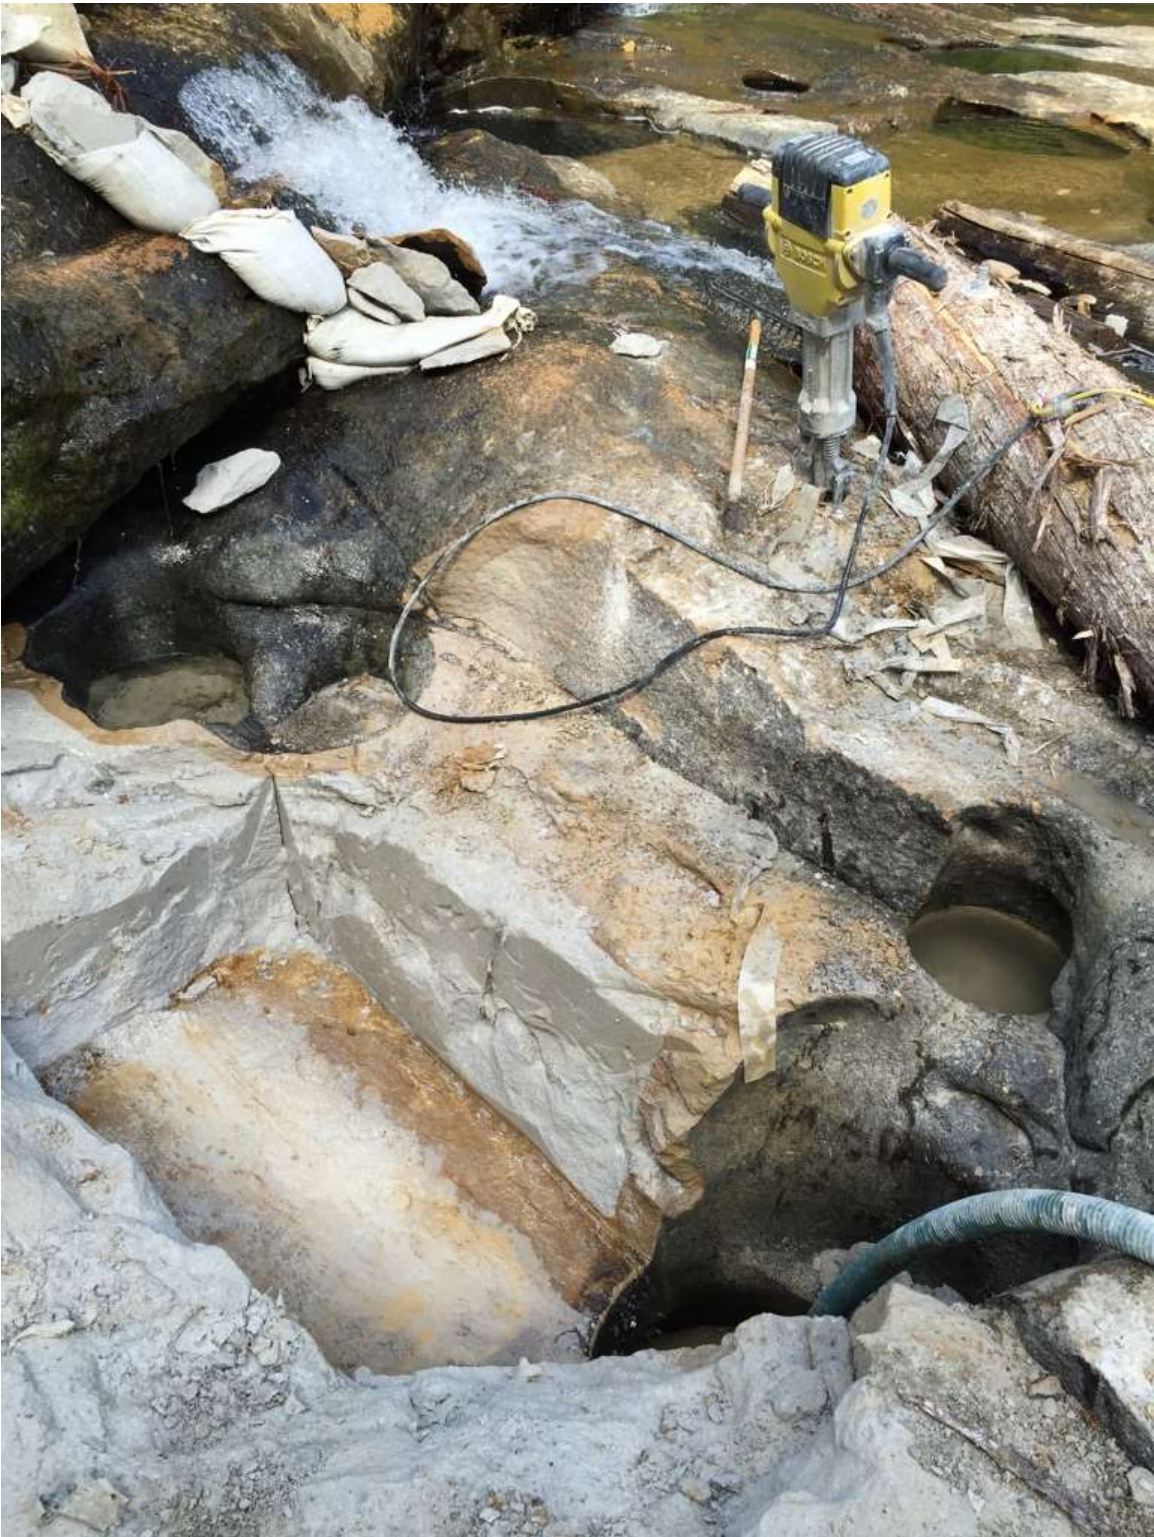
**Photo 17.** A combination of local dewatering and relief cuts greatly improved the effectiveness of the demolition hammer.

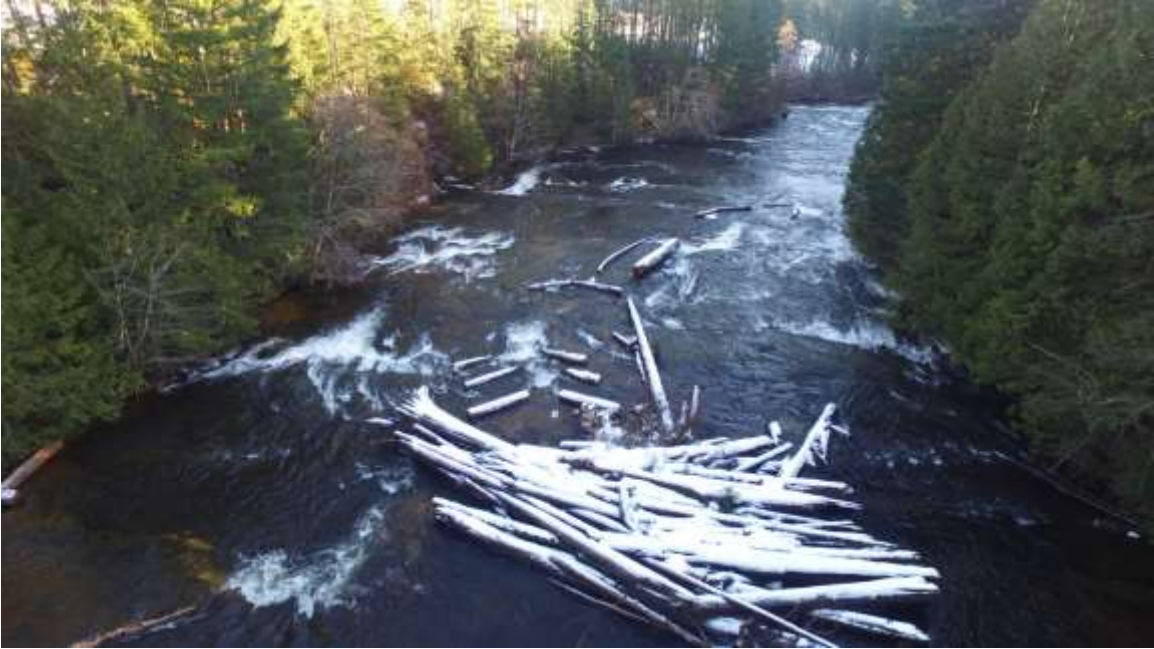
**Photo 18.** Aerial view of the upper site showing the effectiveness of the anchored logs at confining and redirecting flow.
